Dredge Island

Operations, Maintenance, and Monitoring Plan

Alcoa (Point Comfort) / Lavaca Bay Superfund Site

September 2003

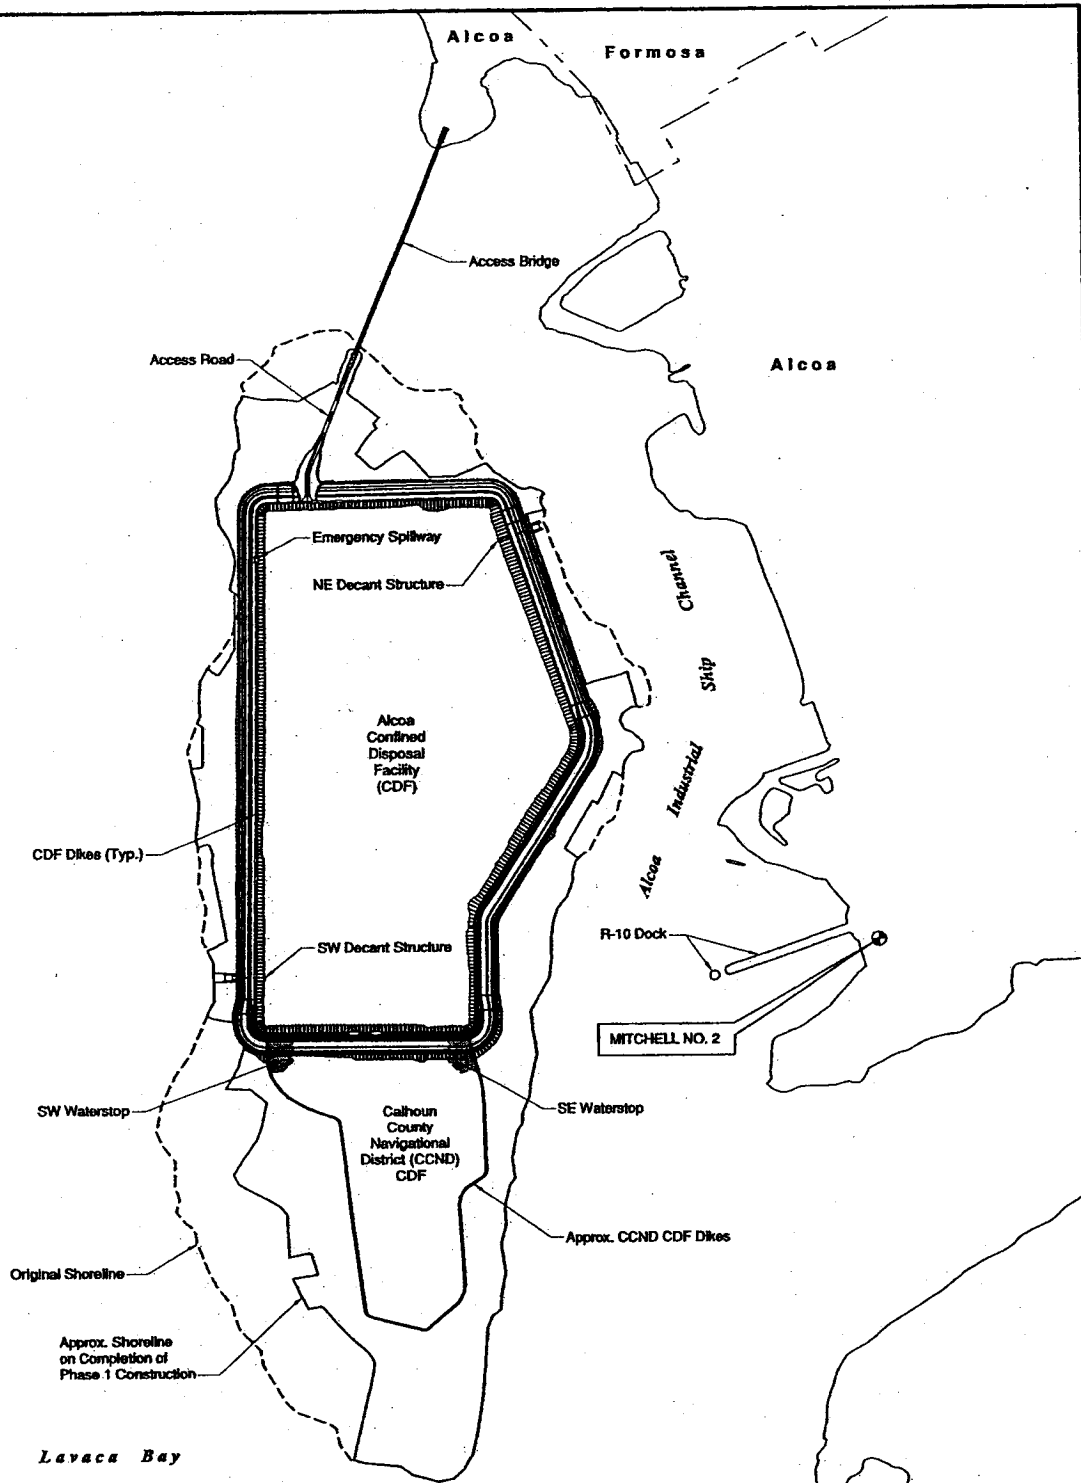
**FIGURE 1-2
DREDGE ISLAND CURRENT
CONFIGURATION**

PROJECT: 020101	DATE: APRIL, 2002
REV:	BY: ZGK CHECKED: MKW

The following construction activities were completed at the Dredge Island as a result of the remedial action, as illustrated on Figure 1-2:
